Thomas Attin, Patrick R. Schmidlin, Tobias T. Tauböck

Direct restorative technique in posterior teeth to treat erosion-induced tooth wear

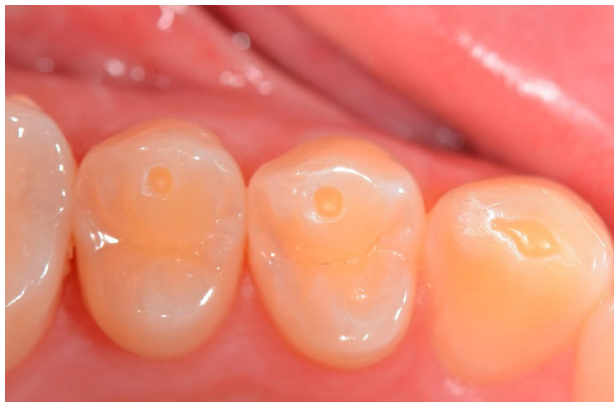
Figure 1 Dental situation of a 33-year-old patient with trough-shaped erosions at the cusp tips of the premolars and at the canine. Simultaneously, an abrasion facet is present at the cusp tip of the canine tooth.

In the case of smaller, often trough-shaped dentin defects, it is usually sufficient to selectively fill and seal these surfaces with flowable composite materials to prevent further progression of the defect (Figs. 1 and 2).

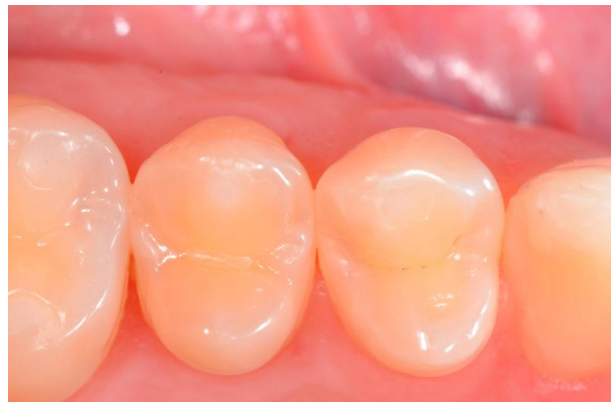
Figure 2 Situation after filling the trough-shaped defects with flowable composite. The cusp tip of the canine was supplemented with a highly viscous composite.

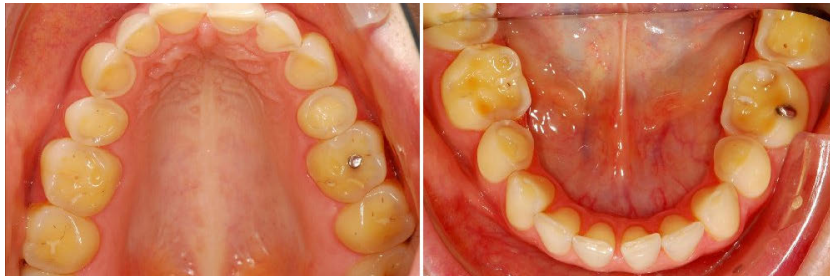
Figure 3 Occlusal view of the initial situation of the patient described in the case report.

As shown in Figure 3, the patient had advanced erosive defects on all teeth, mostly with dentin involvement. In the posterior region, mainly the occlusal surfaces were affected. The maxillary anterior teeth showed shortened dental crowns as well as palatal and labial significant loss of tooth structure (Fig. 4). The patient was particularly disturbed by the appearance of her maxillary anterior teeth. In addition, the posterior teeth showed disturbing hypersensitivity. The patient was informed in detail about various treatment options and opted for a restoration with direct adhesive composite restorations, as she wanted the procedure to be as gentle on the teeth as possible.

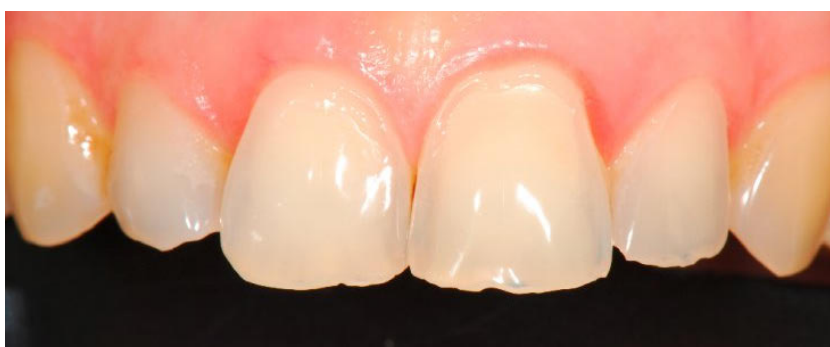
Figure 4 Anterior situation of the patient.

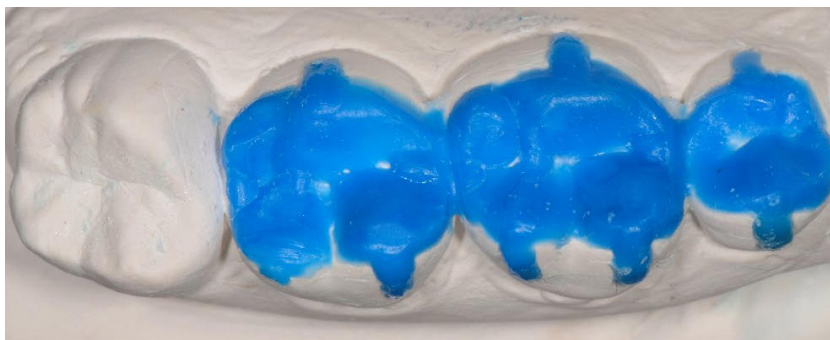
Figure 5 Wax-up of the posterior teeth with omission of the last molar, which was later built up freehand. The “drainage grooves” modeled buccally and lingually with wax at the time are no longer provided by the authors today.

in habitual intercuspitation was performed. In the dental laboratory, the ideal occlusion was waxed up by approximately 2 mm with the anterior teeth blocked. During the fabrication of the wax-up models, the anterior teeth and the posterior portions of the terminal molars were not built up (Fig. 5). On these models, two translucent transfer splints each were fabricated from transparent acrylic for the maxilla and the mandible, which were relined with a transparent silicone-based bite registration material (Fig. 6). The non-waxed areas later allow stable support of the splints in the patient's mouth.

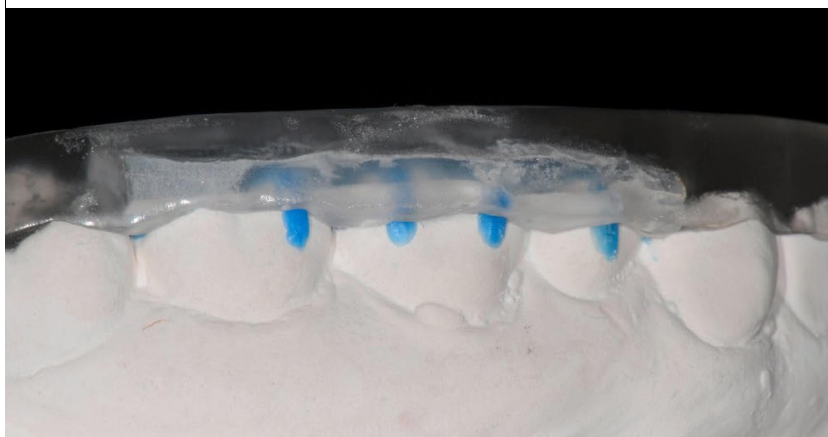
Figure 6 Wax-up model with transfer splint. In the vertical direction, the splint is extended as short as possible. This allows the composite filled in the splint to flow out after the splint has been pressed onto the tooth row.

posterior region with direct occlusal composite build-ups. The highly viscous composite material used for the restoration was filled into the splint in a quantity corresponding to the missing tooth structure and heated to 68 °C for 5 min under light protection on a heating plate (Calset, Ad-Dent, Danbury, USA). Heating reduces the viscosity of the composite material, thus facilitating the placement of the splint on the dentition. Laboratory tests have shown that heating the composite does not affect the material properties [31]. The short vertical design of the splints allows excess material to flow off well when the splint is placed and most of

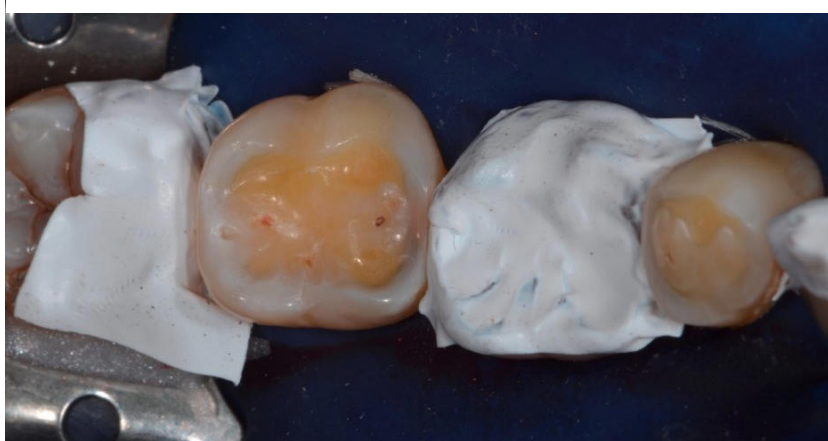
Figure 7 Isolation of the adjacent teeth with Teflon tape.

After placing rubber dams, the adjacent teeth of the teeth to be initially restored were isolated with Teflon tape

to prevent interdental entanglement (Fig. 7). Existing composite surfaces of the teeth were roughened with an intraoral sandblaster with 50 µm aluminum oxide powder (Hager & Werken, Duisburg, Germany) in accordance with the procedure for corrective fillings. The eroded or sclerosed dentin surfaces were refreshed with a fine-grain diamond before application of the etch-and-rinse adhesive system. Studies have shown that such pretreatment significantly improves the bond strength to erosively or sclerotically altered dentin [5, 6]. Similarly, sandblasting the dentin at a pressure >5 bar with aluminum particles >30 µm can have a positive effect on the bond strength of adhesives [14].

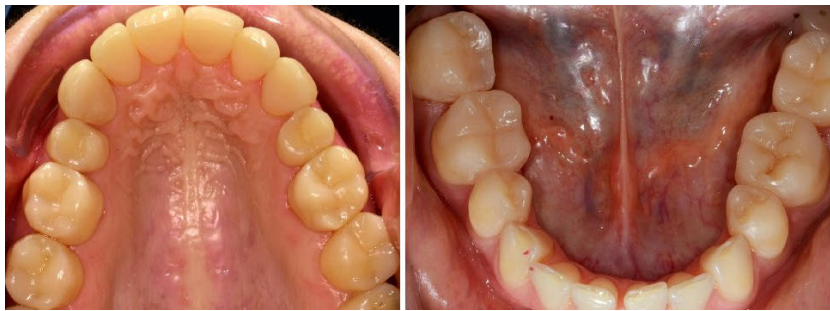
Figure 8 Situation after completion of the occlusal composite restorations.

The splint was placed on the dentition with pressure. After removing the accessible excess, the composite material was light-polymerized through the transparent splint. The light polymerization was initially performed only briefly for approx. 3–5 s, so that after removal of the splint any remaining excess of the not yet fully cured composite could be easily removed with a scalpel. Subsequently, a second (long) light poly-

The difficult-to-access proximal surfaces of the composite abutments were finished and smoothed with single-sided diamond files in a reciprocating angle piece (Swingle, Intensiv, Grancia, Switzerland). Subsequently, the now already restored teeth were isolated with Teflon tape and the remaining posterior teeth were built up as described above and finally polished. The areas not included in the wax-up and the splint were finally reconstructed freehand with composite (Fig. 8). The bite elevation in the posterior region created sufficient space for a subsequent reconstruction of the anterior teeth, which was then fabricated. To protect the restorations from nighttime grinding, the patient was given a grinding splint made of soft acrylic after completion of all restorations. The patient has regular recall appointments. Apart from minor maintenance work, e.g. occasional polishing of the margins of the restorations, no further reworking of the restorations was required during the follow-up visits, which have now lasted eight years. Moreover, the images taken after eight years of wear show only minor signs of wear on the restorations (Figs. 9 and 10).

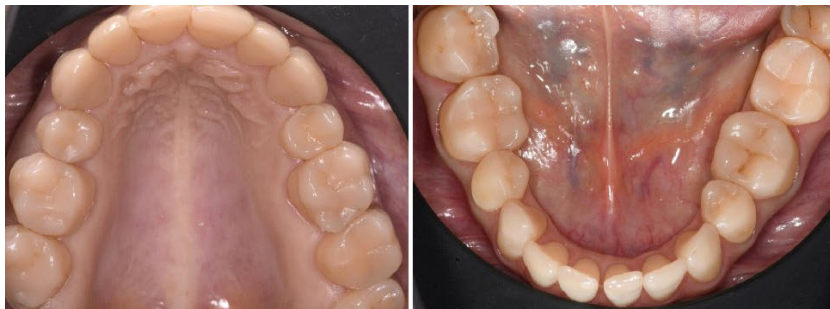
Figure 9 Situation eight years after insertion of the composite abutments with continued satisfactory results.

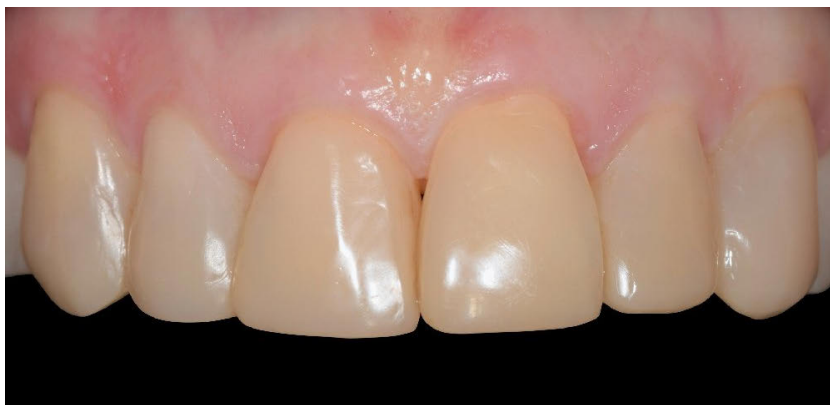
Figure 10 Labial view of the anterior teeth restored with direct composite.
